# Smoke and Dye Testing Summary

## High Level Sewershed

Test ID	Test Type	Date Inspected	Company / Super.	Blower MH	Ground Condition	Notification Made?	Total Length
S1028-014	Smoke	8/7/2008	ADS/TM	S09YY_004MH	Dry	Yes	1,692.23

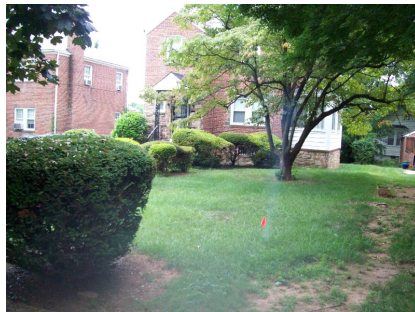
**Picture** \S1028-014-OB01-P01.jpg

**Source** Cleanout

**Location** Yard - front

**Comments** Smoke from cleanout in front yard. 3405 Sequoia Ave.

**Comments** Front of house, 3405 Sequoia Ave.

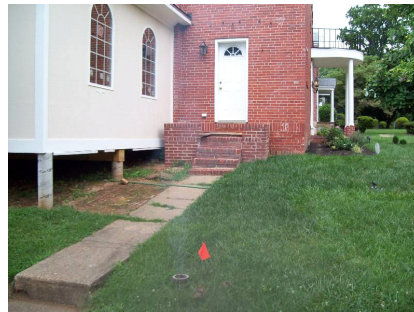
**Picture** \S1028-014-OB02-P01.jpg

**Source** Cleanout

**Location** Yard - side

**Comments** Smoke from cleanout in side yard. 3401 Sequoia Ave.

**Comments** Front of house, 3401 Sequoia Ave.

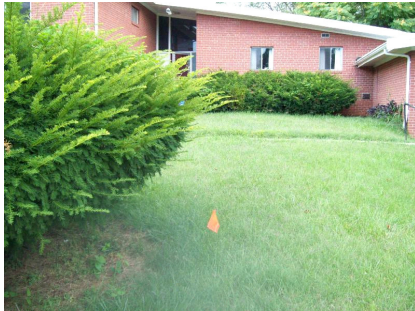
**Picture** \S1028-014-OB03-P01.jpg

**Comments** Smoke from cleanout in front yard. 3702 Denison Rd.

**Comments** Front of house, 3702 Denison Rd.

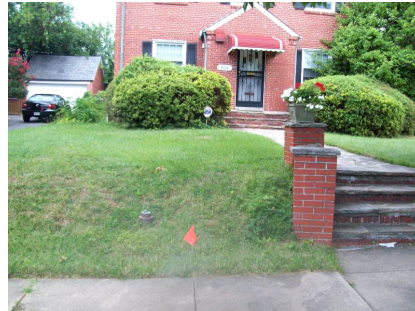
**Picture** \S1028-014-OB04-P01.jpg

**Source** Service Lateral

**Comments** Smoke from service lateral near the sidewalk. 3700 Denison Rd.

**Comments** Front of house, 3700 Denison Rd.

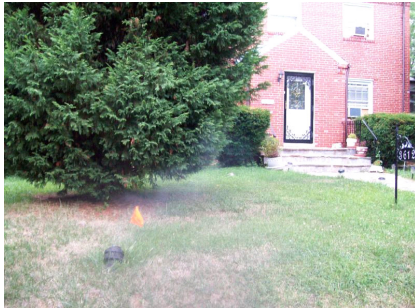
**Picture** \S1028-014-OB05-P01.jpg

**Comments** Smoke from cleanout in front yard. 3612 Denison Rd.

**Comments** Front of house, 3612 Denison Rd.

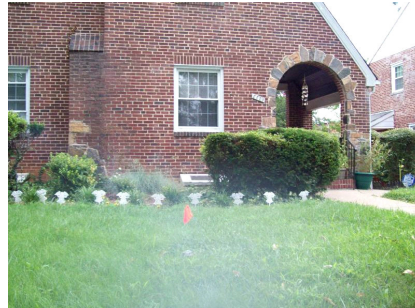
**Picture** \S1028-014-OB06-P01.jpg

**Comments** Smoke from cleanout in front yard. 3529 Denison Rd.

**Comments** Front of house, 3529 Denison Rd.

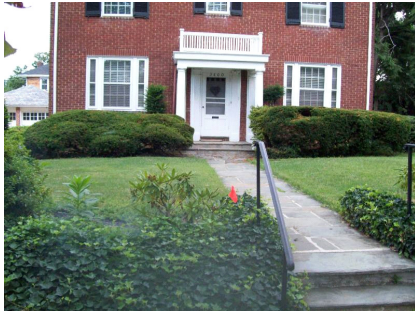
**Picture** \S1028-014-OB07-P01.jpg

**Source** Service Lateral

**Comments** Smoke from service lateral in front yard under bush, next to stairs. 3600 Denison Rd.

**Comments** Front of house, 3600 Denison Rd.

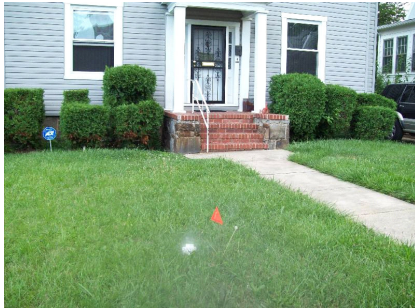
**Picture** \S1028-014-OB09-P01.jpg

**Comments** Smoke from cleanout in front yard. 3506 Denison Rd.

**Comments** Front of house, 3506 Denison Rd.

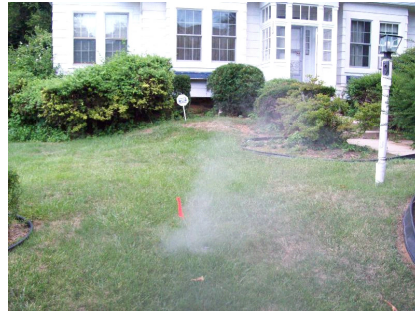
**Picture** \S1028-014-OB08-P01.jpg

**Comments** Smoke from cleanout in front yard. 3508 Denison Rd.

**Comments** Front of house, 3508 Denison Rd.

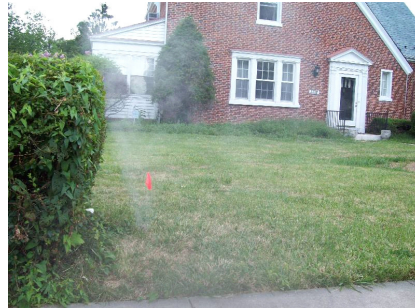
**Picture** \S1028-014-OB10-P01.jpg

**Comments** Smoke from cleanout in front yard. 3318 Dorchester Rd.

**Comments** Front of house, 3318 Dorchester Rd.
